# Manhole Inspection Summary

Manhole # S35YY\_016MH

Insp Date: **12/27/06 12:56 PM**

**Location** Address: **311 33RD ST**

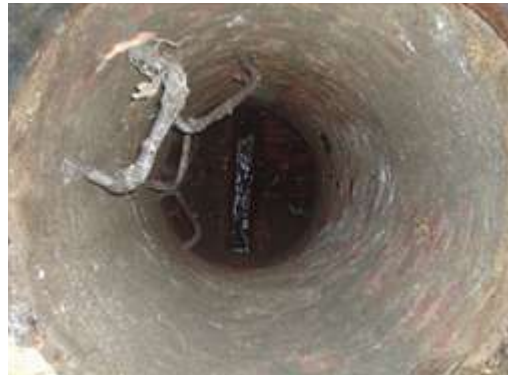
Top View

☒ **Debris** (not Condition related)

Bench debris.

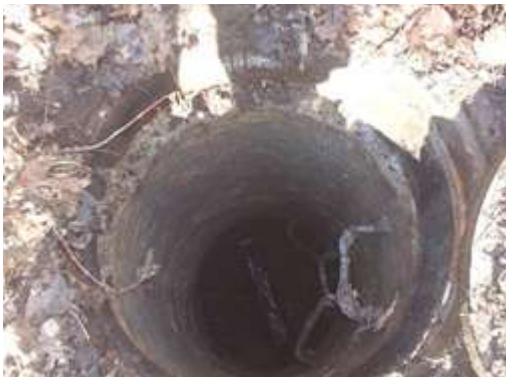
Defect

Offset: **3** (in.)

☒ **Leaks**

Condition: ☐ Sound ☐ Cracked ☐ Root Intrusion ☐ Loose Brick ☒ **Deteriorated**

Infiltration: ☐ None ☒ **Joint** ☐ Cracks ☐ Mortar ☐ Roots ☒ **Wall**

Frame leaks. Frame offset. Adjustment deterioration and infiltration.

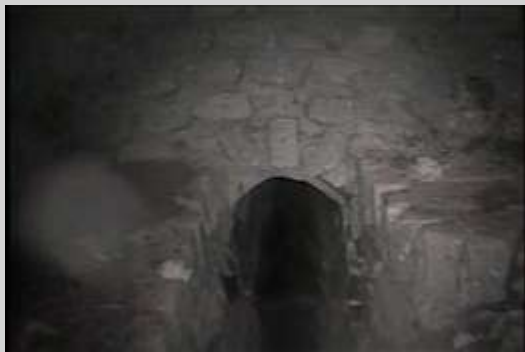
### 8 in. Circular Gravity Sewer Pipe Out @ 12 O'Clock

Infiltration: **Evidence** Pipe Seal Cond: **Unknown**

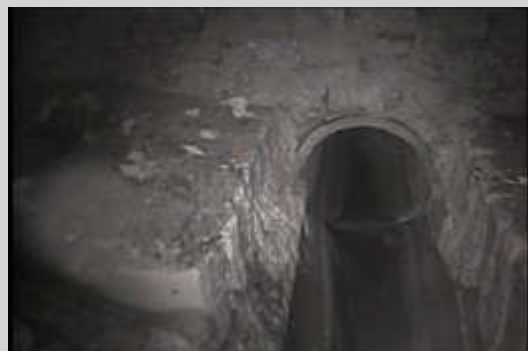
8 in. Circular Gravity Sewer

Infiltration: **Evidence**
